Robotic Refuelling Mission

Demonstrating Satellite Refuelling Technology on Board the ISS

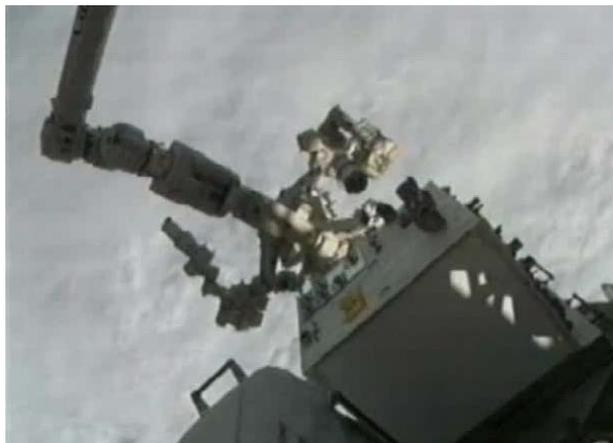
Figure 1: SPDM in Position at RRM Worksite

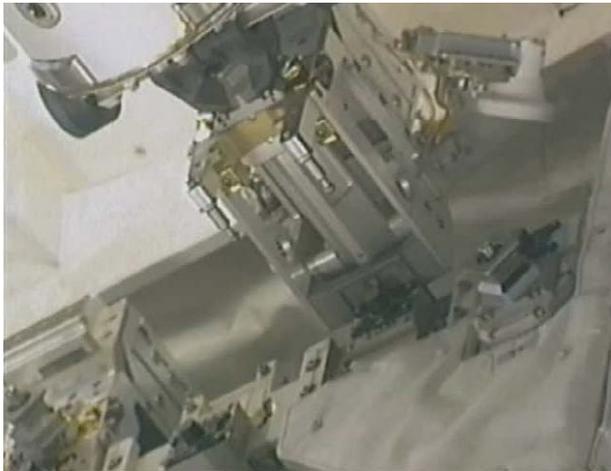
Figure 2: One of the RRM tools being removed from the RRM ToolBay

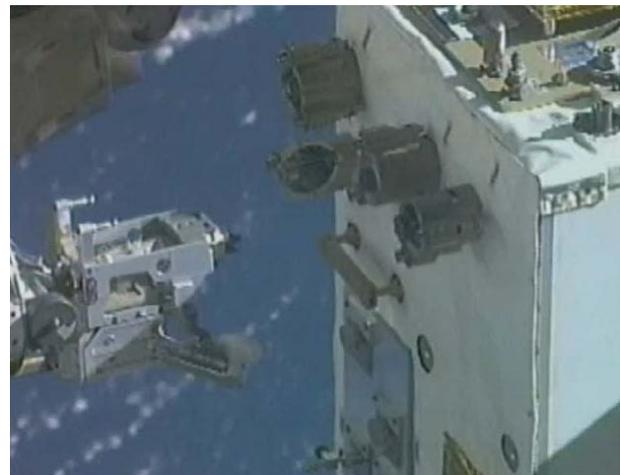
Figure 3: MFT positioned to acquire adapters for CVT1 operations (photo credit NASA/CSA)

In order to completely align the features of the adapters with the features on the worksite, the MFT required very small motions of the SPDM torque mechanism. The torquer was designed to fasten and unfasten tie down bolts on On-Orbit Replaceable Units (ORUs), not for high accuracy mechanism actuation. In particular the torquer is designed to back-off a short distance once the operation is complete.

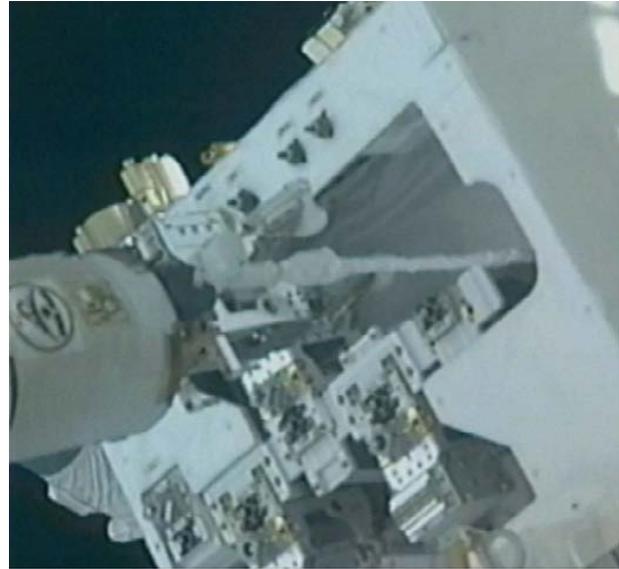
Figure 4: The ENT with Tether Shown in Extracted Position

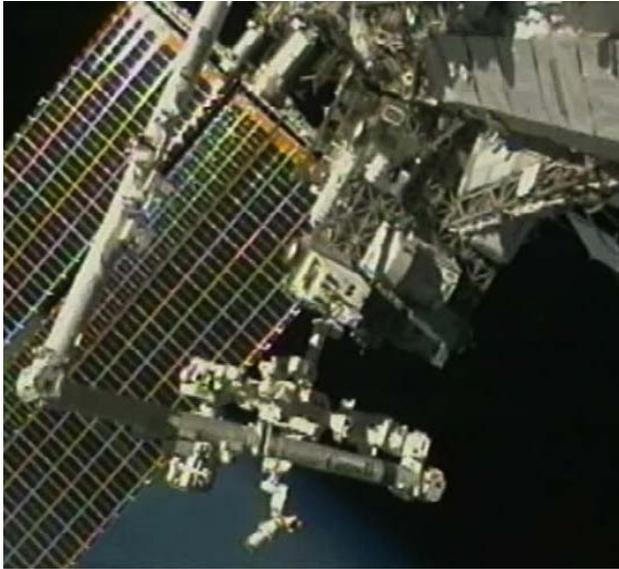
Figure 5: MSS Configured for RRM Operations at ELC4 in Unstabilized Configuration

Day 5 of Fuel Transfer operations saw the MSS setup for the ENT operations by using Arm2 to grasp the Express Logistics Carrier (ELC)4 Nadir H-Fixture for stabilization. Since the SPDM sits at the end of the 17m long SSRMS, external loads such as the ENT tether can cause unwanted deflections in the SSRMS. Figure 4 shows the MSS in configuration for non-ENT RRM operations.

Manipulating a tethered payload, in this case the ENT, was the primary challenge for the MSS. The tether forces induced by the ENT hose necessitated using the second arm on the SPDM to stabilize the MSS. In the unstabilized configuration, simulations conducted at CSA showed that the ENT hose could cause the tip of the tool to deflect significantly due the flexibility in the system, which is dominated by the flexibility in the SSRMS. Using the second arm to grasp a fixed point on the station eliminated the flexibility from the SSRMS and thus eliminated the majority of the unwanted tip deflections.

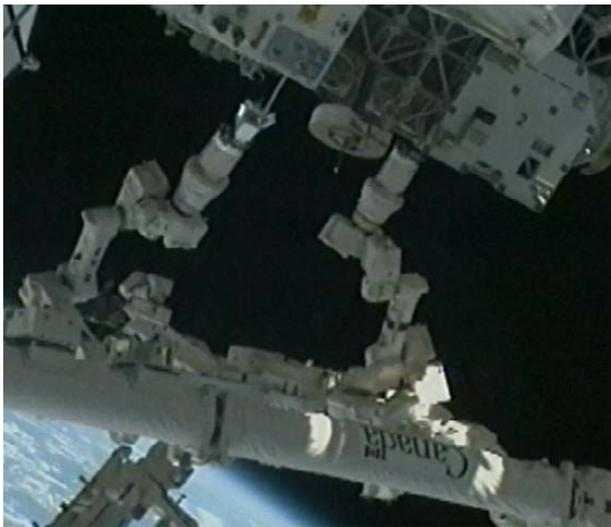
Figure 5 shows the MSS stabilized. Arm 2, the stabilization arm can be seen on the right while Arm 1, on the left is shown holding the ENT.

Figure 6: MSS Stabilized for RRM Operations at ELC4

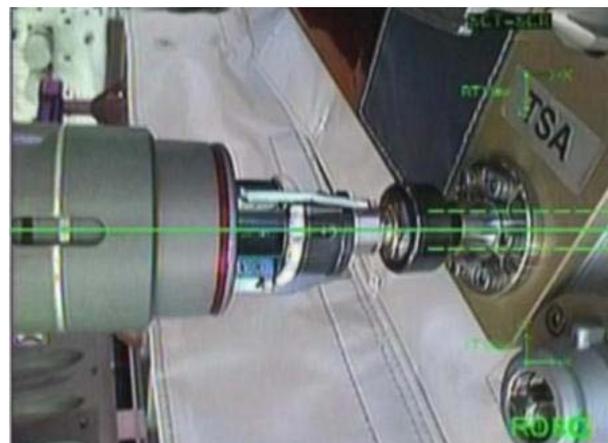
Figure 8: SCT seated on the TTSA

During the SCT operations, six (6) attempts were required to fully seat the SCT on the TSA. This was due to the fact that SPDM normally relies on FMA to correct any misalignments required to attain a perfectly aligned configuration and achieve full seat.

In this case there was a combination of initial

misalignments coupled with moments that were not large enough for the SPDM to detect in order to correct the small misalignments which prevented the SCT from properly seating on the TSA. The video signal quality may also have contributed to the difficulties in alignment.

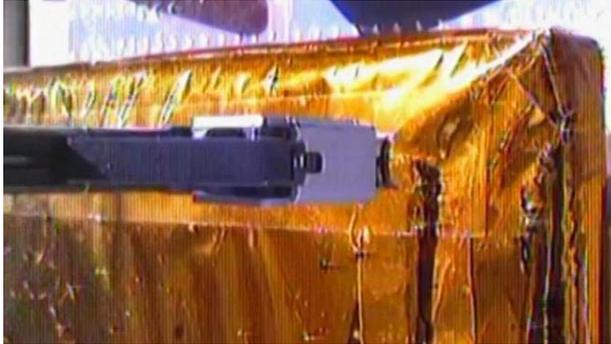
Figure 9: WCT Cutting a Corner in the Kapton MLI

Day 3 (May 6, 2013) operations resumed with re-fastening one (1) of the screws previously unfastened. With the SCT operations complete, the MSS was reconfigured for MLI cutting and manipulation tasks using the WCT (Figure 9).

The MLI Kapton involved piercing a small hole in the Kapton blanket with the cutting spade and then cutting a 3-sided tab in the blanket. The first cut involved several attempts but was eventually successful. While starting the second cut however, the Kapton ripped and several small pieces were seen floating away. Operations were halted and the MSS was backed-off to a park configuration.

Manipulating the MLI with the tip of the WCT proved easier than expected. Cutting the MLI was a greater challenge. When cutting the MLI, the major difficulties were in trying to limit the forces to an amount slightly above the minimum limits of the SPDM capabilities, during performance of small motions while in contact with a flexible surface.

The goal was to limit the loads to prevent tearing the MLI. In addition, the motion was constrained to prevent the blade from contacting the surface below the blankets while maintaining a straight cut. This proved to be feasible but it was difficult to keep the blade from exiting the cut. It was also very easy to snag if the MLI was not kept tight.

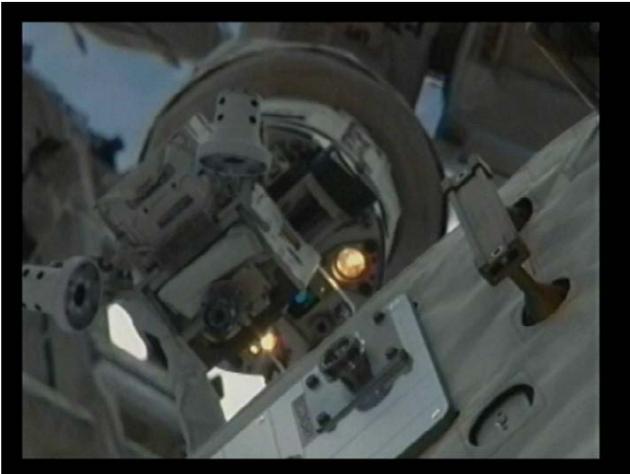
Figure 10: OTCM shown holding the ENT in an inspection position checking for FOD

The RRM has shown that many of the tasks required for robotic on-orbit servicing of satellites is feasible with current technology. Using the RRM tools, the SPDM was able to successfully demonstrate the robotic techniques required to align the tools for successful contact operations, limit the loads using FMA and manipulate constrained payloads such as the ENT (Figure 10).
